RESERVE ANALYSIS REPORT

High Rise Condominium

Sample, New England

November 20, 2017

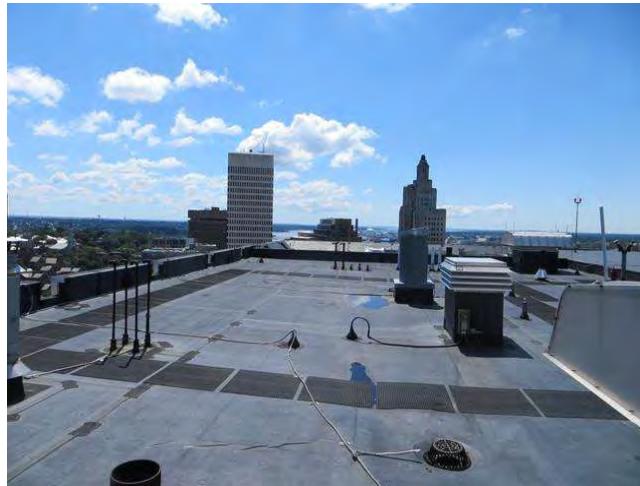
EPDM roof membranes on towers A and B are about halfway through useful life. Roofing quantity calculated from building plans.

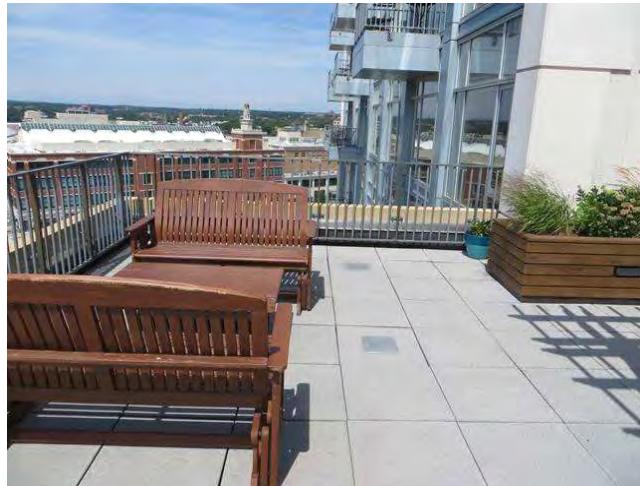
Component covers concrete pavers on tower roof decks/terraces. Paver quantity calculated from building plans.

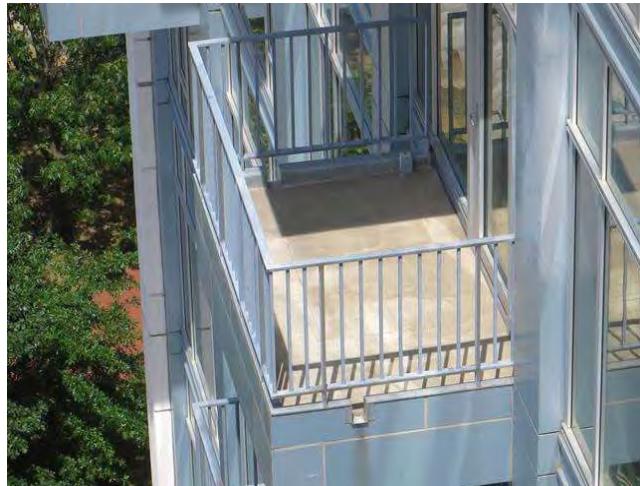
This component covers balcony surface coatings. Balcony concrete should be protected from water intrusion to prevent corrosion of reinforcement steel and spalling. Balconies adjoin units and could not be inspected closely during site visit. Some balconies pitch toward building, but no other issues were reported by client. Balcony flashings at building should be inspected regularly to insure water is not entering the building at these vulnerable intersections. Underside of concrete balcony should also be inspected for evidence of leakage. Balconies that pitch toward building should be examined more carefully.

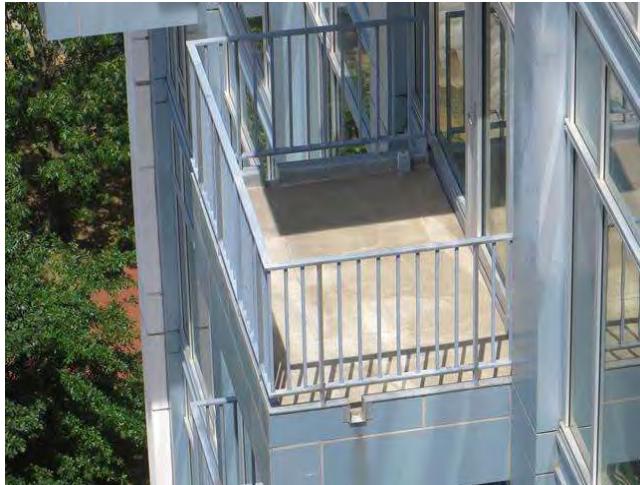
This component covers cleaning and top coating balconies on a 5-year interval. Balcony concrete should be protected from water intrusion to prevent corrosion of reinforcement steel and spalling.

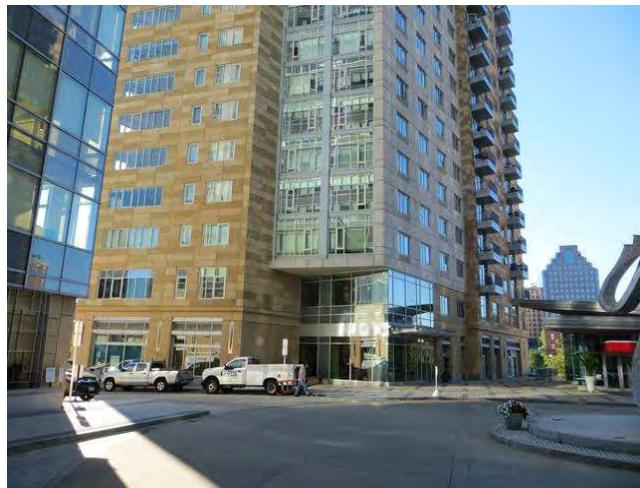
Component covers repair to expansion joint between plaza and Tower A. Per client, this is expected to be a one-time repair. Cost provided by client.

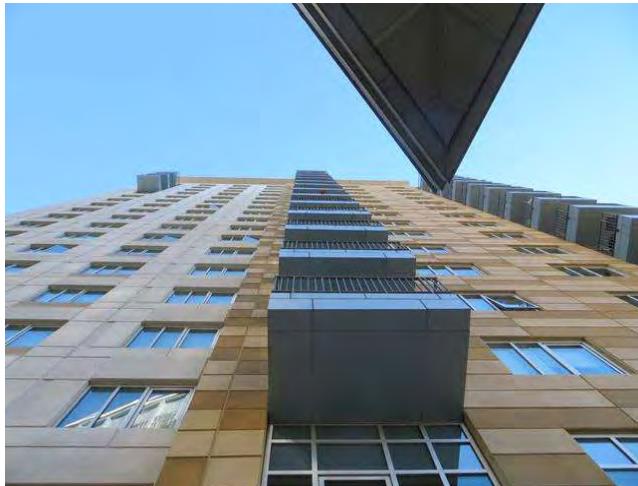
Condition of exterior tower cladding appeared good during site visits. No specific issues were noted. No significant work has been done on exterior cladding per client. No significant issues currently.

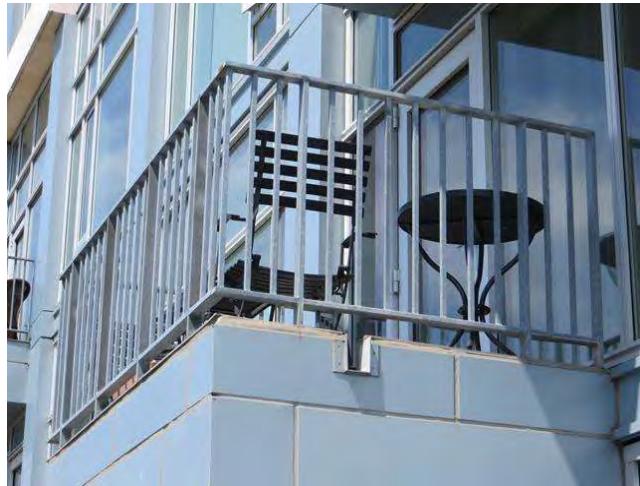
Galvanized railings are original to building and were in generally good condition during site visits. Some evidence of corrosion was evident and should be addressed. Regular maintenance will insure railings achieve their useful life. Pricing obtained from similar railings in Boston. Material for new rail replacement is galvanized steel. Solid 3/4" balusters. Logan Grate, Inc., fabrication and installation contractor, anticipates a Useful Life of 30 years for new railing/fencing with proper maintenance. Galvanized coating will protect iron fence if coating not damaged.

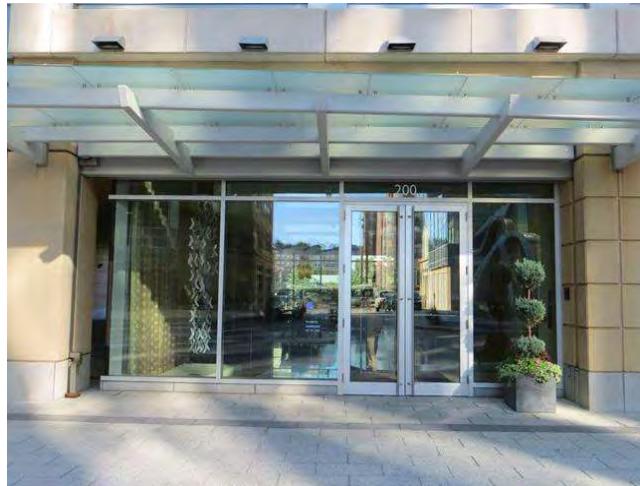
Component covers repair of canopies over tower entry doors. Glass has failed in past due to snow loads. Tower A has two canopies and Tower B has one. Cost provided by client.

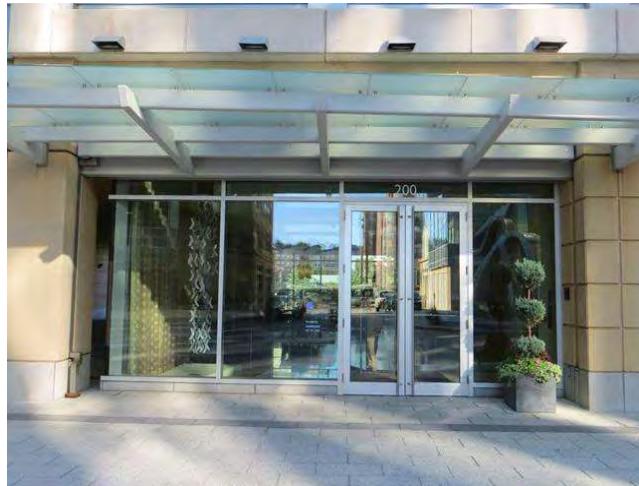
Component represents exterior common storefront window/door areas for both towers on first floor and fitness room on second floor of Tower A. Commercial units on first floor are excluded. Windows and doors were in good condition during site visits and no problems were reported by client.

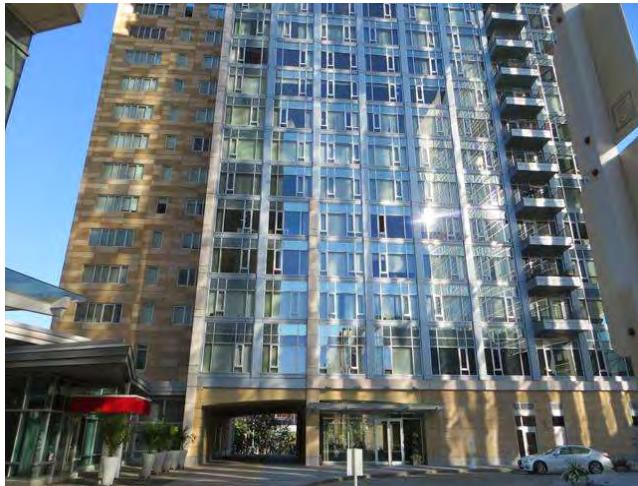
Component represents partial replacement of exterior unit window areas on for both towers. Included are opaque windows and exterior doors on building elevations from floors 2 to the top floor. Cost for this component is 100% association per client. Windows have expected useful life of 30 - 40 years. This component covers replacement of (8) windows at \$7500 every two years at 100% per client. This component should be adjusted as association gains experience with failure rates.

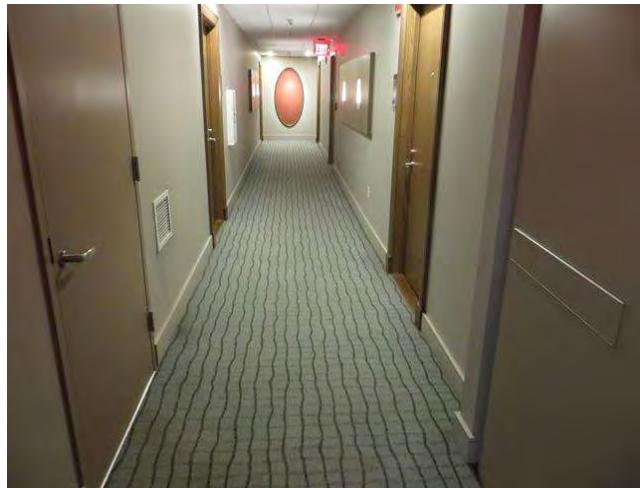
Component covers all association carpet. Quantity from actual measurements. Cost from prior reserve study with inflation added.

Per client, carpet in elevator lobby areas was recently changed on some floors. More elevator lobby carpets will be replaced in near future. Carpet in hallways is in generally good condition and will likely have a useful life of 5 years.

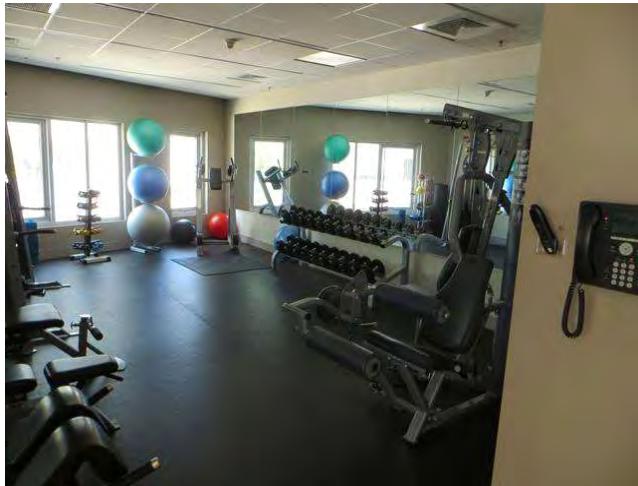
Component covers fitness center rubber tile floor mat in weight lifting area. Quantity from prior reserve study deemed accurate. Cost from prior reserve study with inflation added.

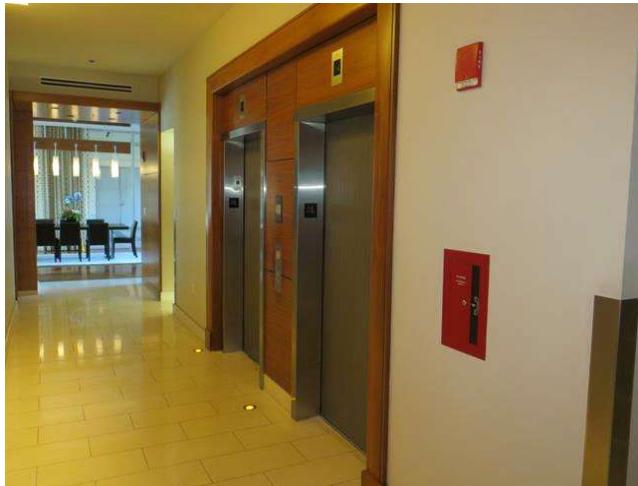
Component covers stone tile floors in tower lobbies. Component not listed in prior reserve study. Stone tiles are cracking and failing. No loose tiles were observed. Useful life decreased to reflect current condition. Client is obtaining proposals to replace tile. Removal of existing tile is difficult to estimate. Cost of materials chosen to replace the current tile can also vary widely. Per square foot cost has been increased due to uncertainty.

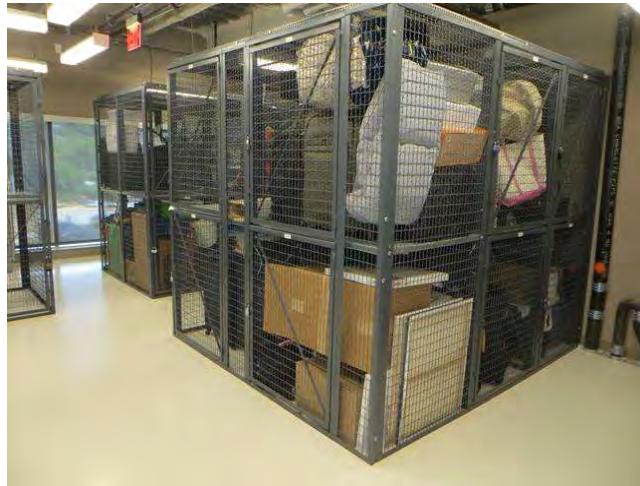
Component covers vinyl tile floor in unit owner storage areas. Quantity from prior reserve study deemed accurate. Cost from prior reserve study with inflation added.

The remaining life of this component has been extended due to its apparent infrequent use.

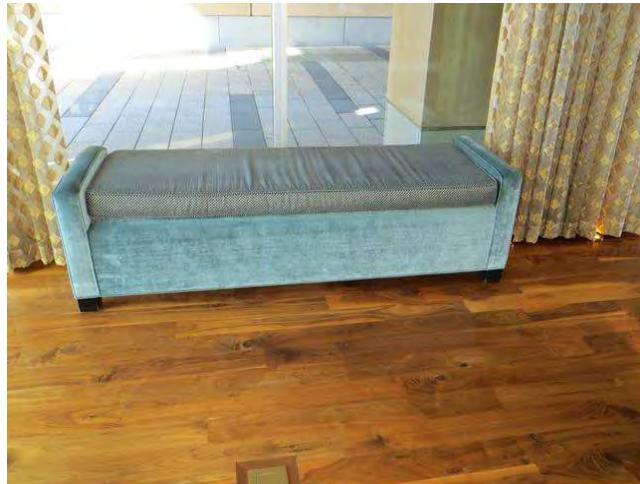
Component covers removal and replacement of wood floors in lobbies and community room. Quantity from prior reserve study deemed accurate.

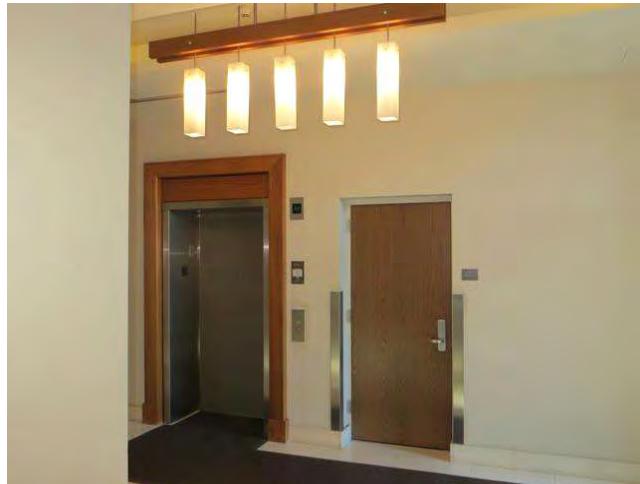
Component covers interior and exterior common area lighting. No quantity listed in prior reserve study. Cost allowance from prior reserve study plus inflation used after consultation with client.

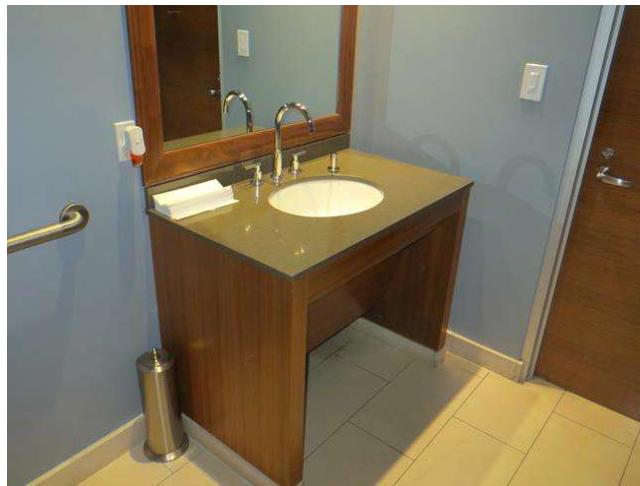
Component covers remodeling common restrooms located in lobby of each tower, fitness center, community room, and garage office. \$15,000 allowance to cover all components of remodel (with fixtures remaining in same locations). Pricing developed with consultation from client.

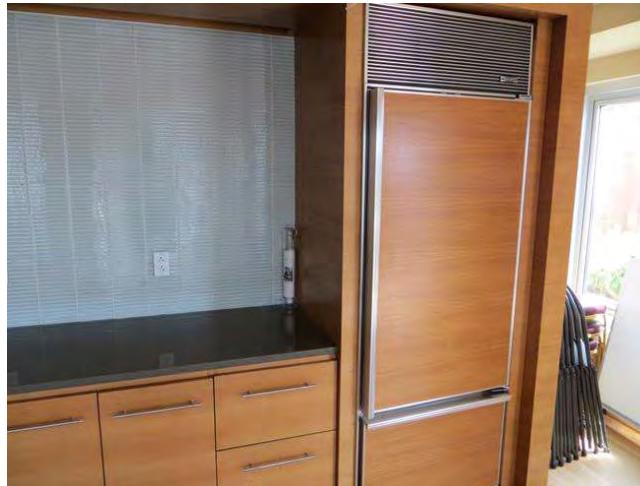
Component covers appliances in community room and both tower lobbies. Also included are TV, sinks and faucets.

The remaining life of this component has been extended due to its apparent infrequent use.

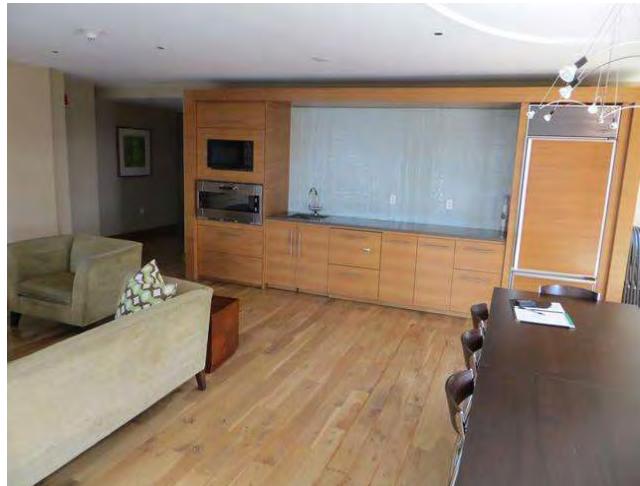
Component covers cabinetry and countertops in community room and both tower lobbies.

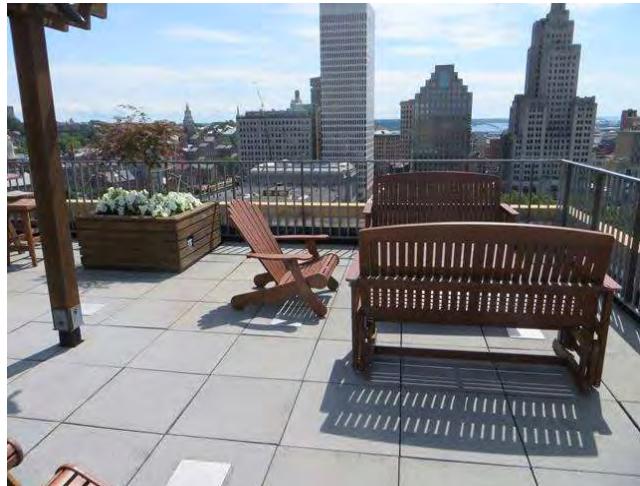
Component covers furnishings on Tower B roof community terrace. Furnishings are maintained with teak oil periodically.

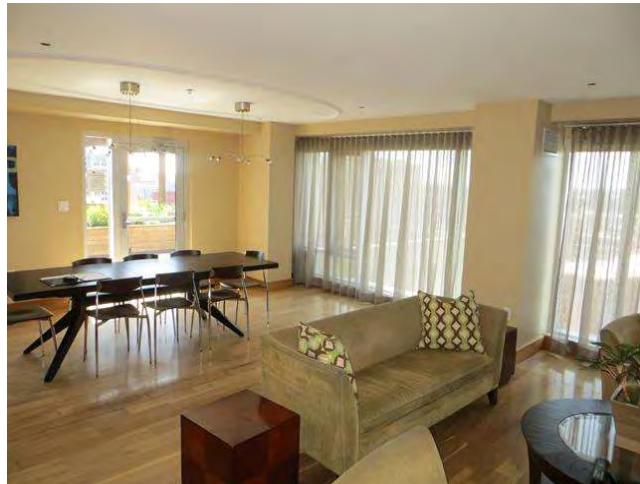
Component covers furnishings in community room. No quantity listed in prior reserve study. Original allowance from prior reserve study adjusted for inflation.

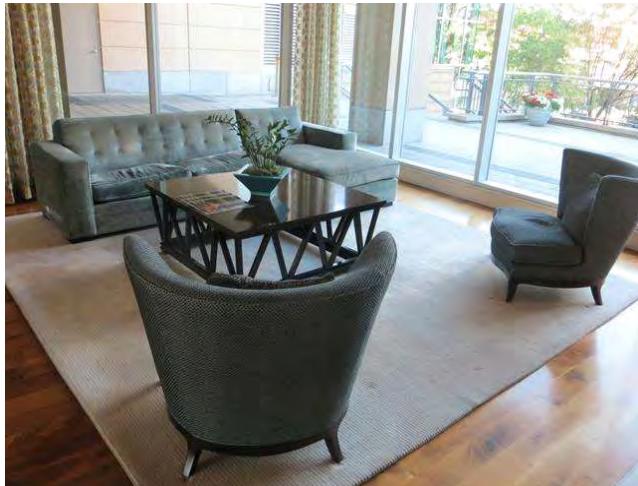
Component covers furnishings in tower lobbies. No quantities listed in prior reserve study. Original allowance from prior reserve study adjusted for inflation.

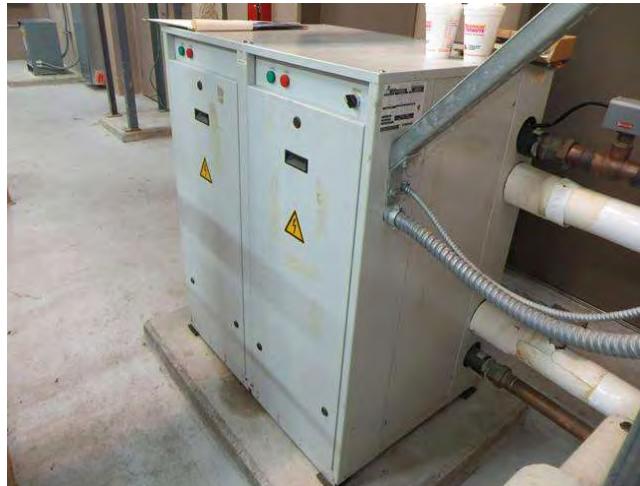
ClimateMaster GLW360CFD1ABRBS 30 ton water source heat pump servicing McQuay International air handler.

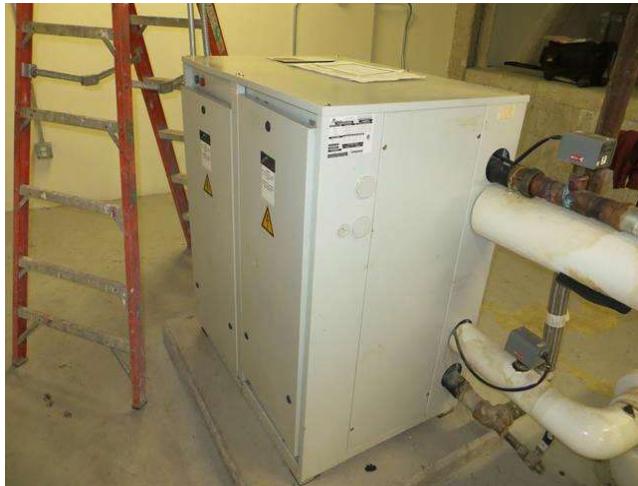
ClimateMaster GLW360CFD1ABRBS 30 ton water source heat pump servicing McQuay International air handler.

(1) 2-stage heat pump packaged in one cabinet for each tower. Labeled HP-9 in both towers.

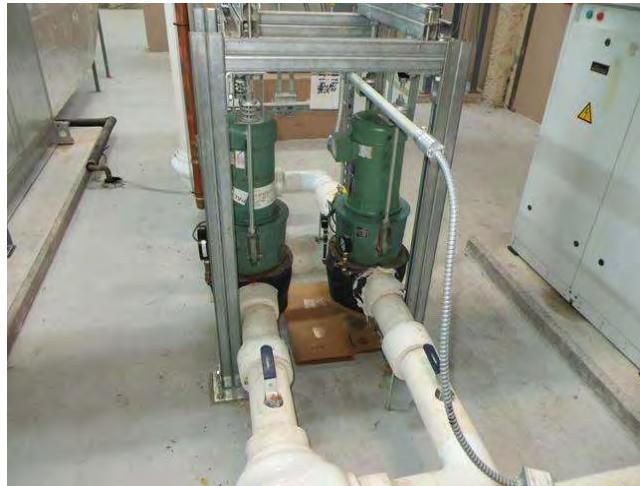
3 hp motor powers Taco 90 GPM circulation pumps servicing McQuay International air handler. Circulate water between water source heat pump and coils inside air handler. Motors operate at fixed speed. (2) pumps for each tower: Pump 7 & 8 tower A

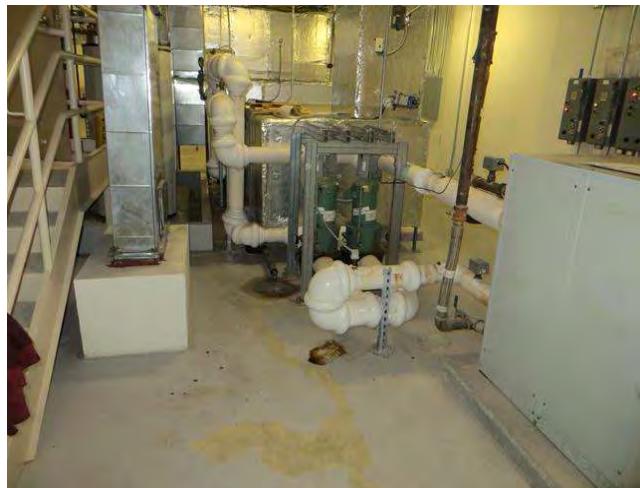
3 hp motor powers Taco 90 GPM circulation pumps servicing McQuay International air handler. Circulate water between water source heat pump and coils inside air handler. Motors operate at fixed speed. (2) pumps for each tower: Pump 9 & 10 tower B.

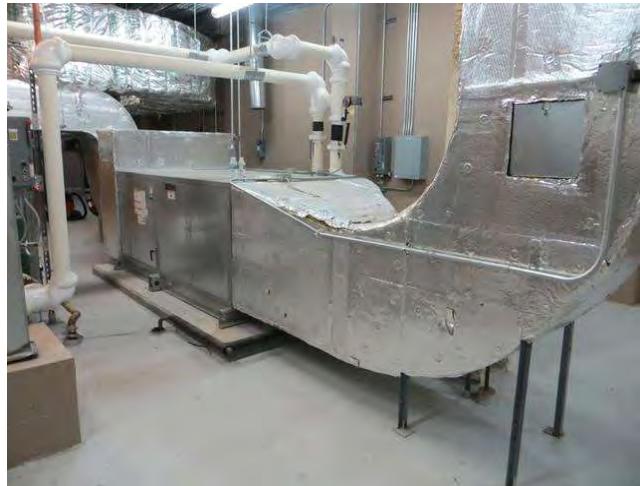
McQuay International CAH012GDAC E805580010 and E805580020 air handlers service common areas on floors 2-19 in tower A. 6000 cfm per prior reserve study.

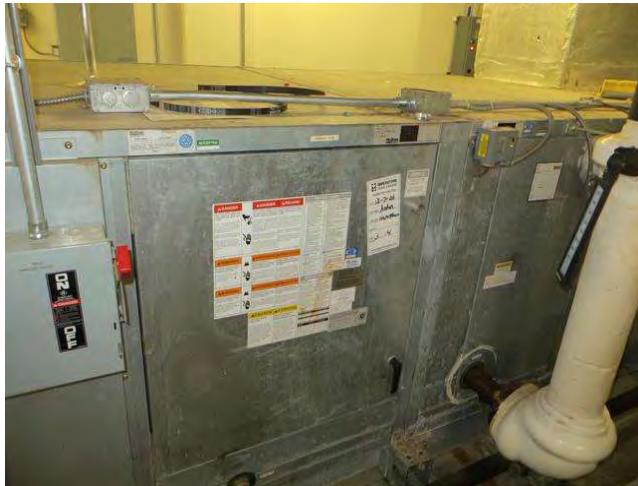
McQuay International CAH012GDAC E805580010 and E805580020 air handlers service common areas on floors 2-17 in tower B. 6000 cfm per prior reserve study.

Service and preventative maintenance contractor:
 Air Masters HVAC Services of NE Josh Medieros 508-672-7993
 System is serviced quarterly. Filter changes and belt checks.

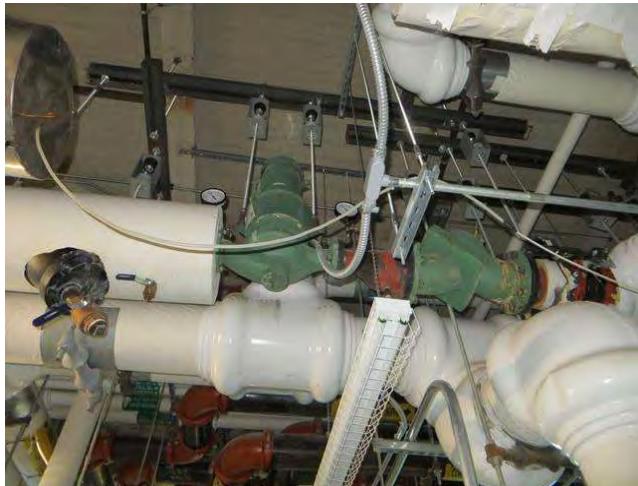
(2) 10 hp pumps (P-11 and P-12) circulate condenser/boiler water within the boilers. Pumps are controlled with variable frequency drives. The system can operate with only one motor/pump. Other condenser water pumps are listed as separate components.

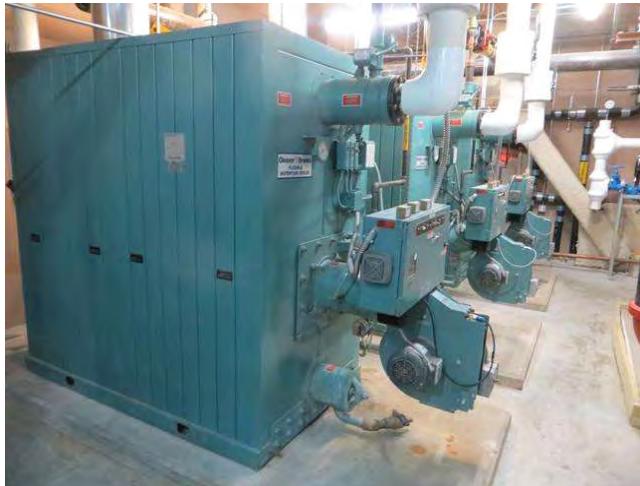
(3) Cleaver Brooks FLX-700-300-160HW gas-fired boilers provide hot water for heating both towers. Capacity is 2400 Mbtu per boiler. Boilers are power-vented through wall to area adjacent to cooling tower.

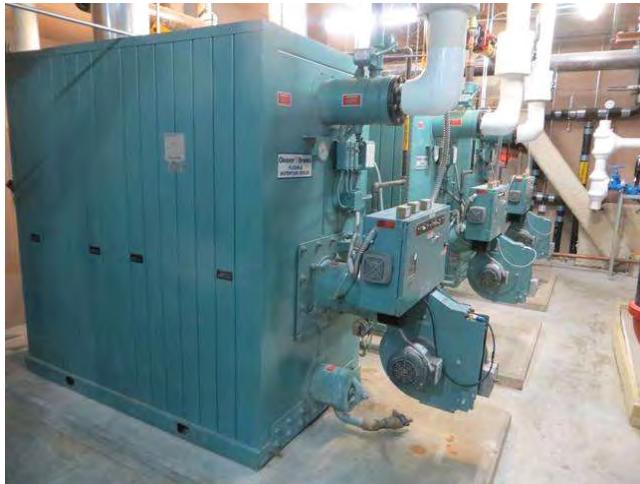
(3) Cleaver Brooks FLX-700-300-160HW gas-fired boilers provide hot water for heating both towers via water-source heat pumps. Component covers scheduled maintenance on 3 year intervals.

Service and preventative maintenance contractor:
 Air Masters HVAC Services of NE Josh Medieros 508-672-7993
 System is serviced annually.

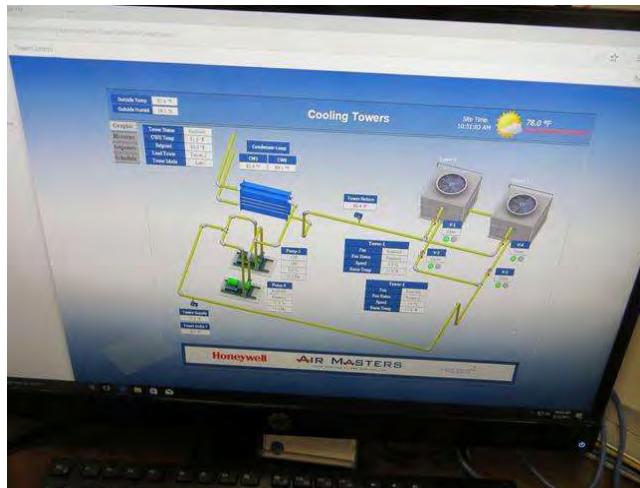
Primarily Johnson Controls system. Some parts of system are Honeywell Tridium. Some changes to system were implemented when Air Masters took over system in 2015. "J" system.

Component covers periodic upgrades and required maintenance on 5 year interval. Adjust allowance based on association experience.

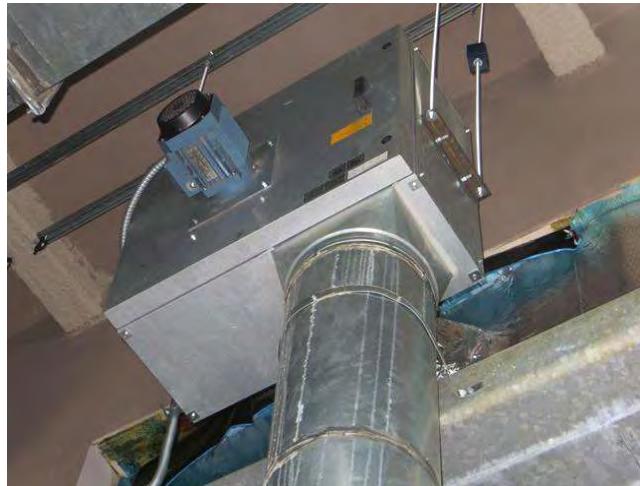
Exhausto fan brings combustion air into penthouse of Tower A for water heaters and boilers.
 Fan hangs near ceiling in south west corner.

Cook fan brings combustion air into penthouse of Tower B for water heaters.
 Fan hangs near ceiling in south west corner.

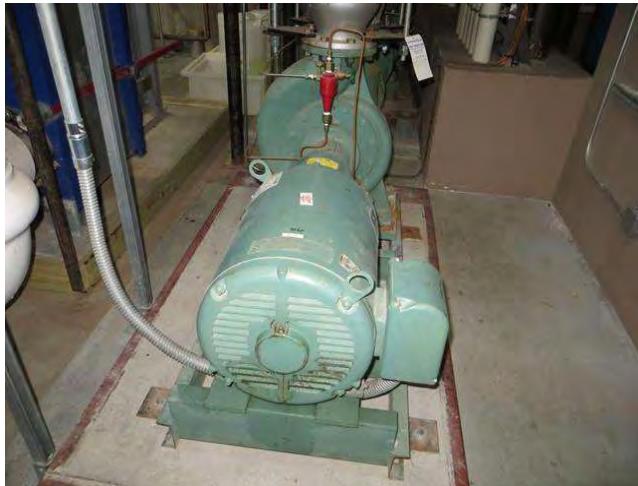
(2) 50 hp pumps circulate condenser/boiler water within the cooling tower and heat exchanger. Pumps are controlled with variable frequency drives. The system can operate with only one motor/pump. Primary and secondary building specific water pumps are listed as separate components.

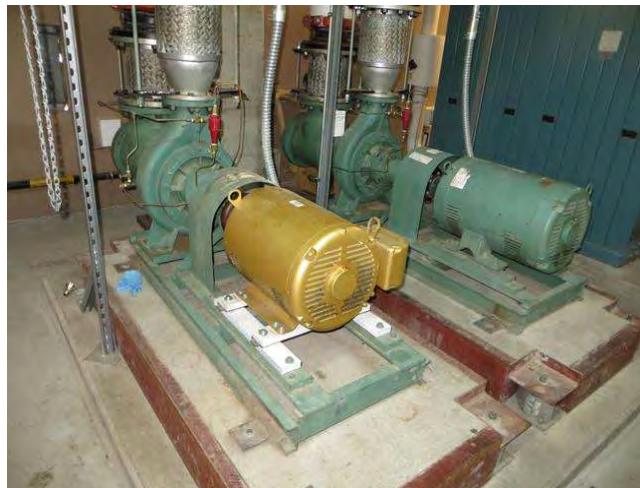
(1) 75 hp pump (P-4) and (1) 50 hp pump (P-3) circulate condenser/boiler water within the boilers and cooling tower. Pumps are controlled with variable frequency drives. The system can operate with only one motor/pump. Secondary building specific water pumps are listed as separate components.

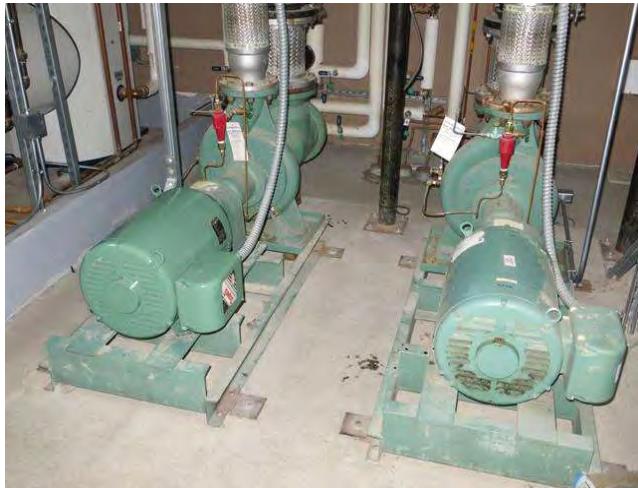
(2) 30 hp pumps, P-1A and P-2A, circulate condenser/boiler water within building 100 operate at approximately 25 psi. Pumps are controlled with variable frequency drives. The system can operate with only one motor/pump. These pumps are secondary to the main condenser water pumps listed as separate component.

Operational experience: motor P-1A was recently rebuilt by Delta, Cranston, RI for \$2880. Failed bearing was replaced.

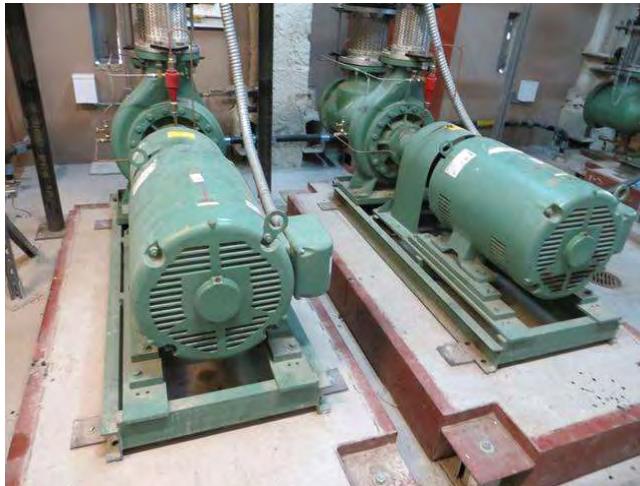
(2) 75 hp pumps, P-2B and P-2B, circulate condenser/boiler water within building 200 (located in #100 penthouse) operate at approximately 30 psi. Pumps are controlled with variable frequency drives. The system can operate with only one motor/pump. These pumps are secondary to the main condenser water pumps listed as separate component.

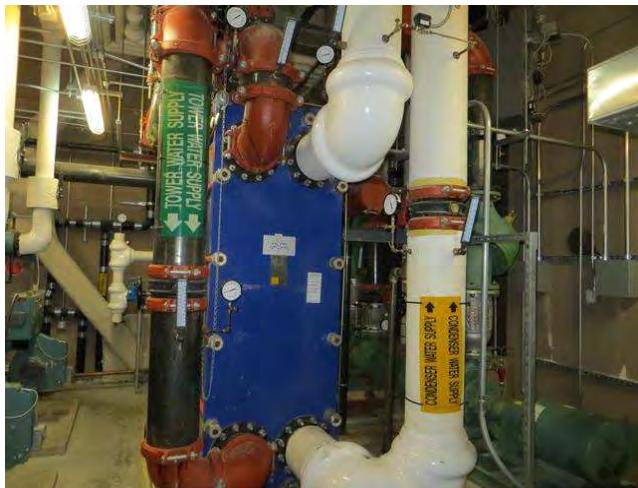
Condensor water heat exchanger provides cooled water to building for air conditioning via water source heat pumps. Cooling tower provides cooled water 75-78 degrees Fahrenheit to heat exchanger. After passing through heat exchanger, condenser water is 80 degrees Fahrenheit maximum. If condenser water reaches 90 degrees, the heat pump systems will shut down.

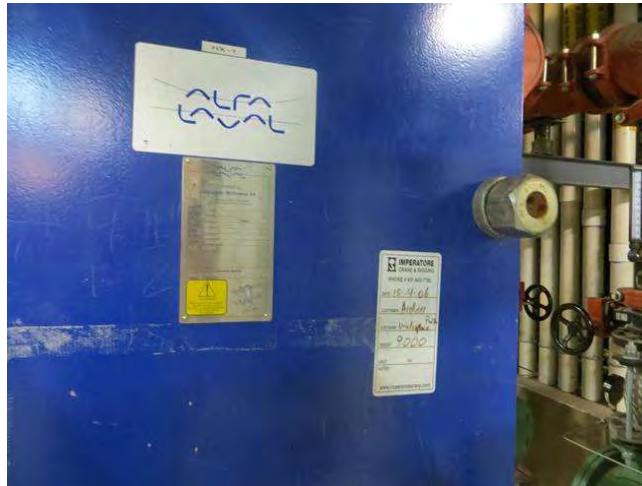
Condenser water heat exchanger provides cooled water to building for air conditioning via water source heat pumps. Cooling tower provides cooled water 75-78 degrees Fahrenheit to heat exchanger. After passing through heat exchanger, condenser water is 80 degrees Fahrenheit maximum.

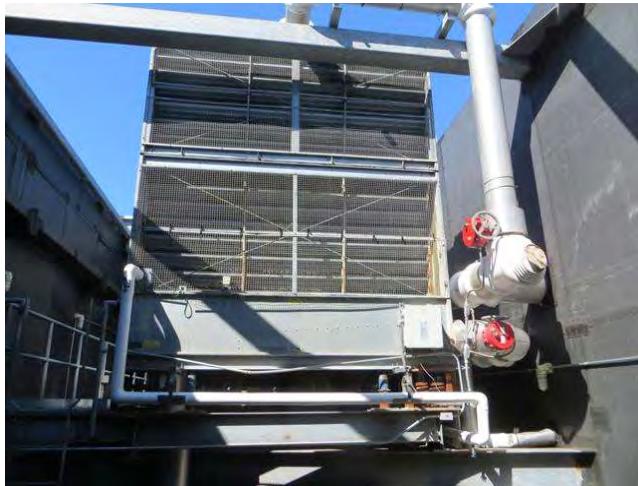
(2) Baltimore Aircoil Company 700 ton cooling towers.

Operational experience: Fan motor developed bad bearing. Variable frequency drive was damaged. Both were replaced for \$9000.

Pricing per discussion with client. Useful life 20-25 years per client research. Service contractor not responsive. Useful life for separate refurbishment component set at 16 years and useful life of cooling tower replacement extended to 25 years.

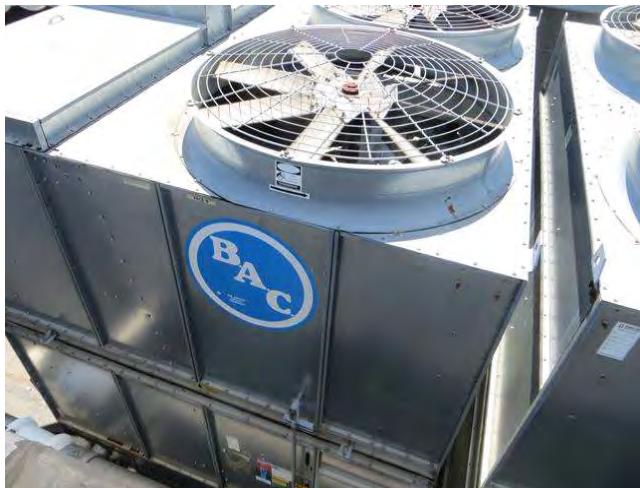
(2) Baltimore Aircoil Company 700 ton cooling towers.

Operational experience: Fan motor developed bad bearing. Variable frequency drive was damaged. Both were replaced for \$9000.

Refurbishment component added per discussion with client. Useful life 20-25 years per client research. Useful life for refurbishment set at 16 years and useful life of separate cooling tower replacement component extended to 25 years.

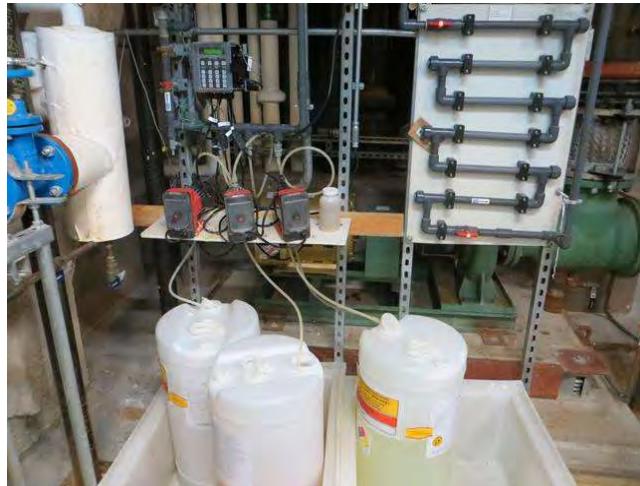
System is operated by Bardons Water Services, East Greenwich, RI.

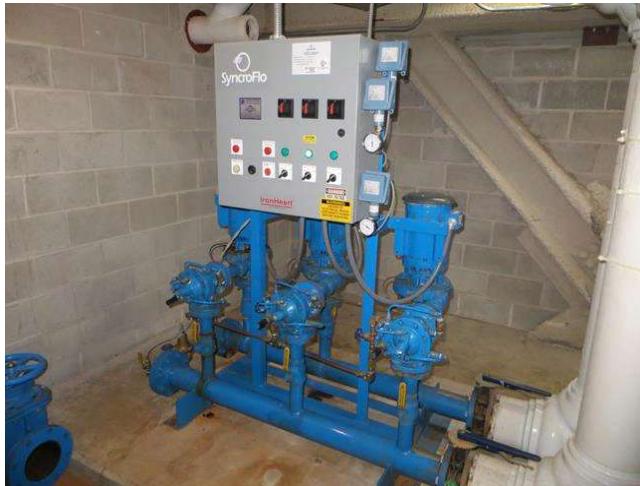
SyncroFlo 55TE74V domestic water triplex booster pumps are powered by 7-1/2 hp motors. 90 gpm per pump.

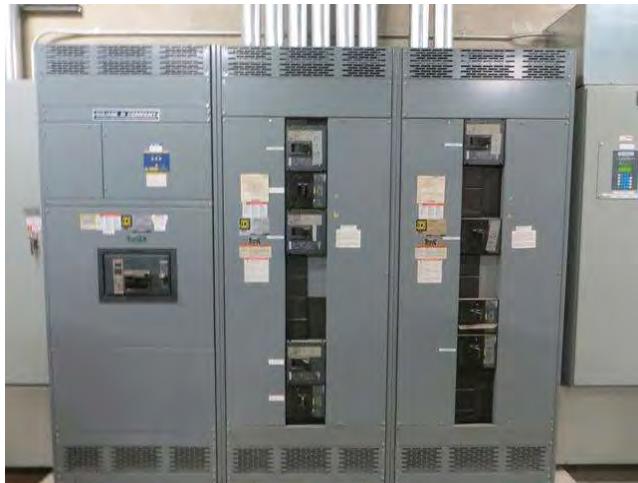
Typically, electrical panels are unfunded.

This component is for allowance for infrared inspection on 3 year interval of all electrical panels and transformers.

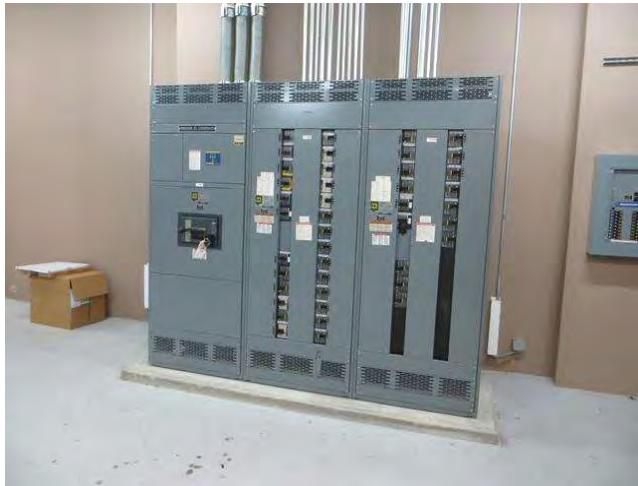
Typically, electrical panels and transformers are unfunded. However, due to the large number of panels and transformers in the association, it is prudent to expect some level of repairs will be required.

This component is for allowance for inspection and replacements on 15 year interval. This allows some funding for occasional, unpredictable repairs. Allowance should be adjusted as more experience is gained as electrical equipment ages.

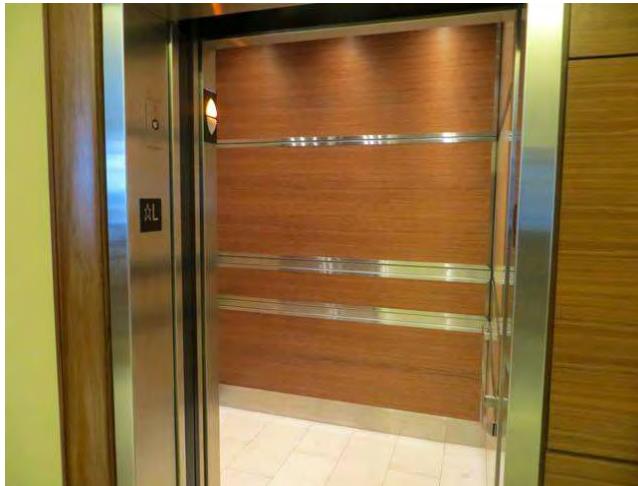
(4) tower elevator cabs

Operational experience: no issues reported in general. Tile floors are cracking.

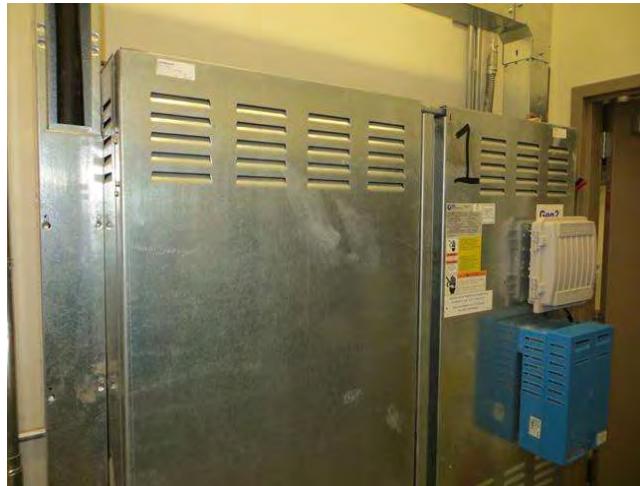
(4) traction elevators, (2) in each tower.

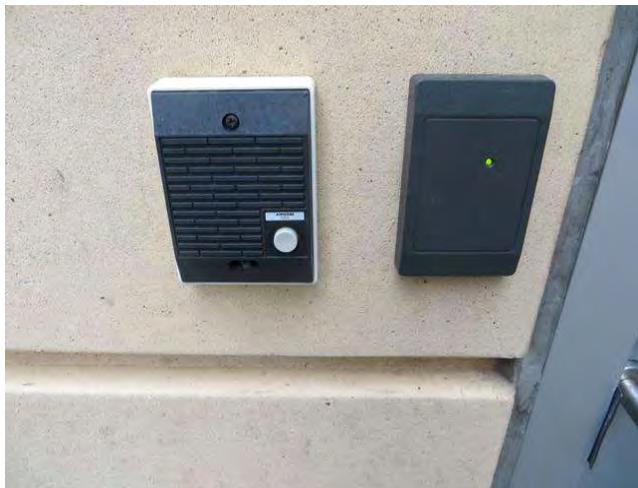
Component covers C.cure 8000 access system. Most components are original. Separate components for intercom system to tower front desks and access dialing system to units.

Field devices have long service life and should be replaced on as-needed basis

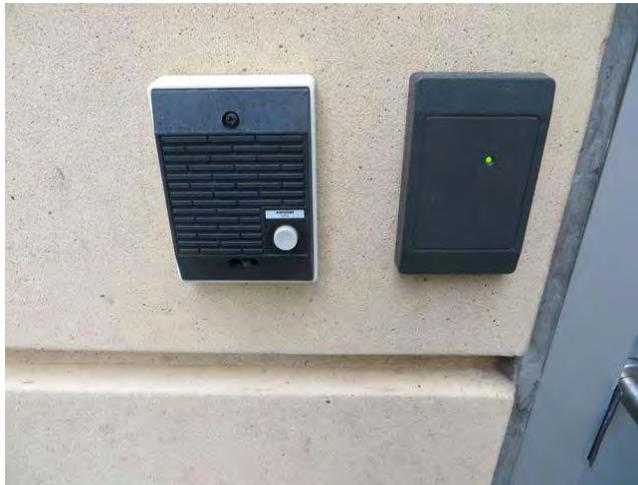
Component covers Aiphone door intercom. Separate components for C.cure access system and access dialing system to units.

Service contractor: Siemens, Canton, MA Mark Derby 781-571-9474
 Current basic stand-alone system does not interface with C.cure system 8000. Main panel for intercom is at tower front desks. Control panels are large and antiquated, but will likely function until an integrated access system is desired. Smaller control panels with similar functionality to current system are available for about \$1000 each. Field devices at entry doors are very reliable.

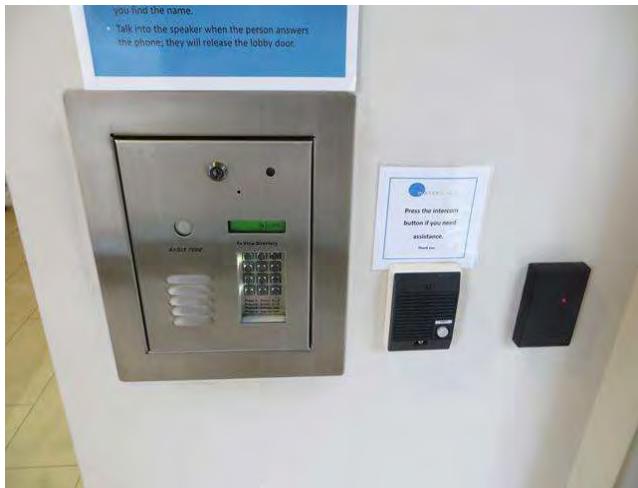
Component covers access control system. Aegis 7000 series allows visitors to call units to gain access to towers.

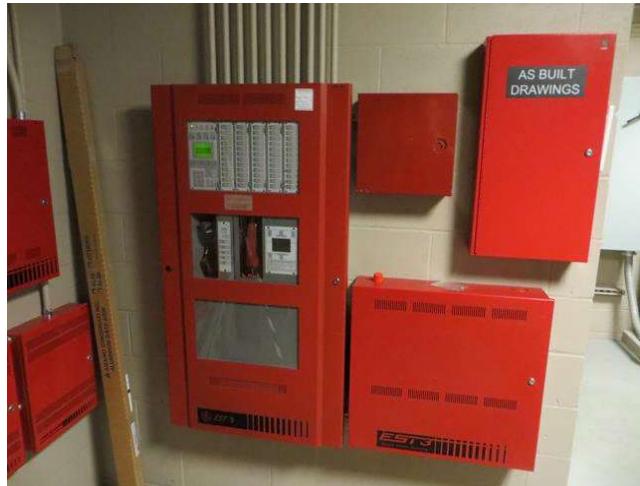
The fire alarm system is composed of Edwards EST3 fire alarm panels and peripheral equipment in the Waterplace towers, garage, and Blue Cross Blue Shield (BCBS) building. Each alarm location has different panel depending on area served. Note that if panels are upgraded in Waterplace and garage, then they also will have to be replaced in BCBS building. Funding for BCBS is not included.

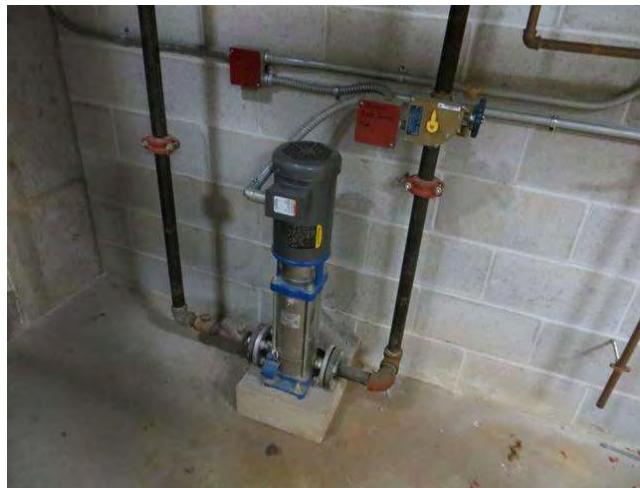
Fire sprinkler jockey pump is in equipment room on level P2 of parking garage.
 3 hp pump maintains wet sprinkler pipes at approximately 260 psi to aid in sensing if a sprinkler head discharges. Jockey pump also eliminates need for main fire pump to run to maintain system pressure.

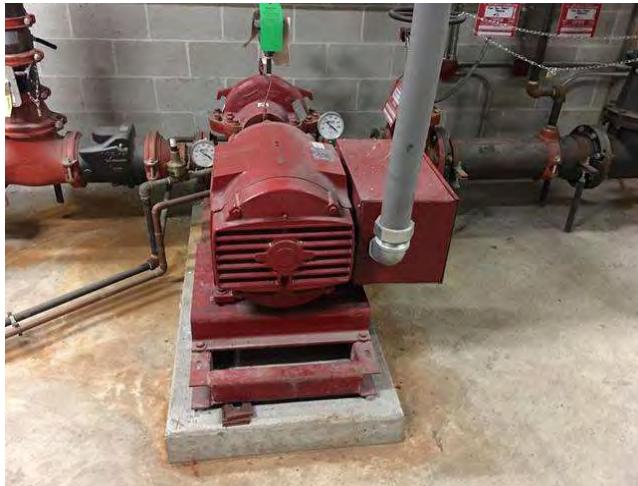
Allis Chalmer fire sprinkler pump is in equipment room on level P2 of parking garage.
125 hp (when operating at 60 HZ) motor with 1000 gpm pump.

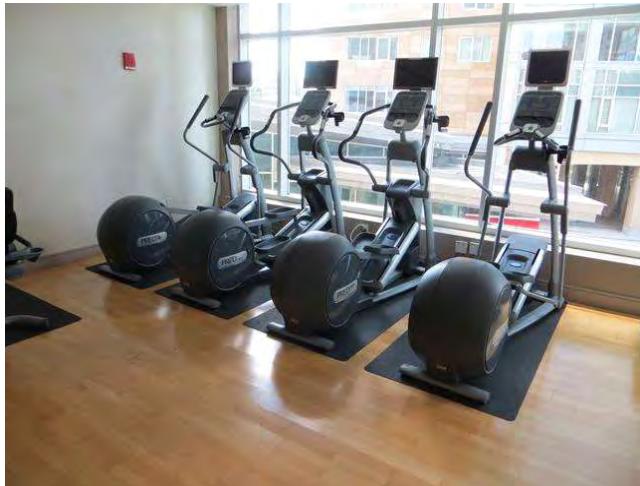
Component covers partial replacement of fitness equipment in the gym on 15 year interval. Most equipment is lightly used. Treadmills receive the most use. Walking decks wear and need periodic repair. Funding from operating budget. A preventative maintenance program is in place. Reviewed strategy with client.

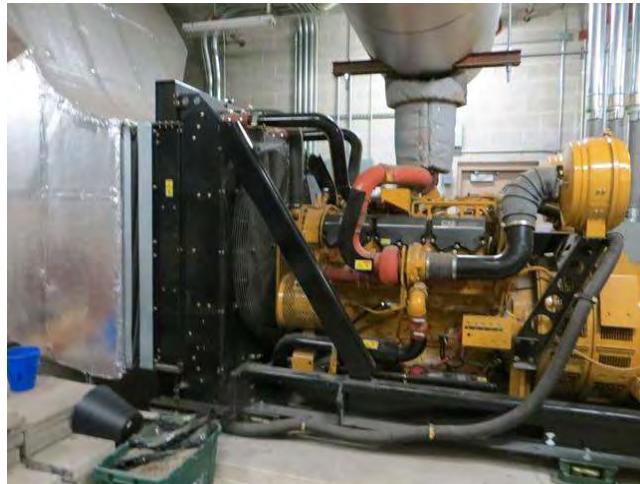
Component covers generator and peripheral equipment. 1000 kw generator has never been needed per client. Waterplace is on same electrical grid as hospital. Power supply has been very reliable. Generator is tested once a week.

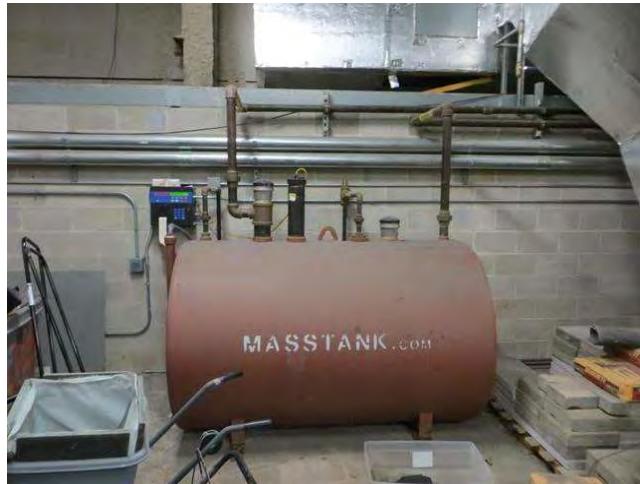
Component covers generator diesel fuel pump. 1000 kw generator has never been needed per client. Waterplace is on same electrical grid as hospital. Power supply has been very reliable. Generator is tested once a week.

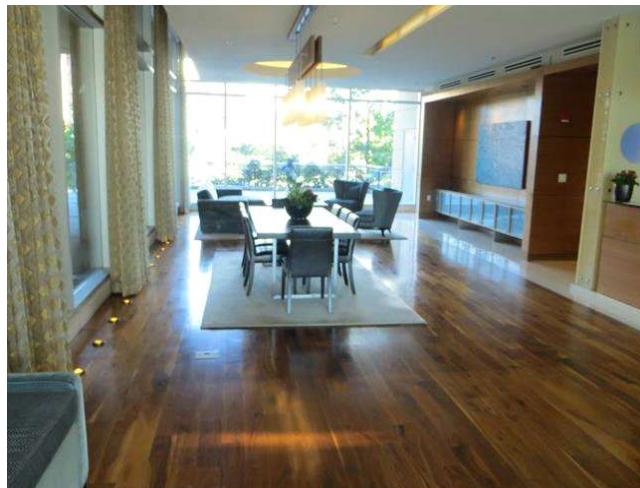
Water-source heat pump locations in common areas:

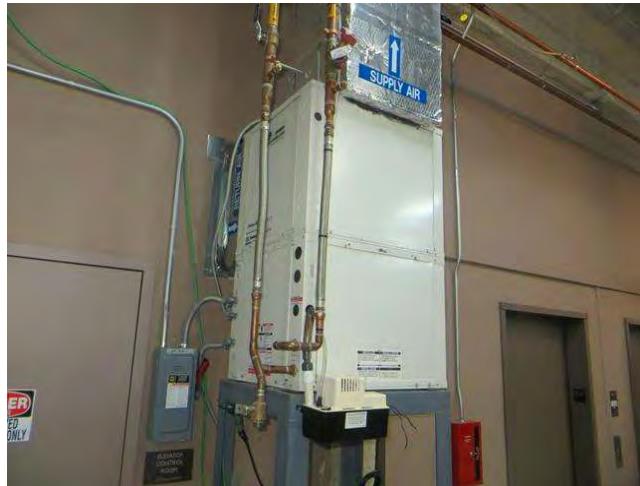
Water-source 3 ton heat pump locations:

Tower A:
(2) for elevator machine room

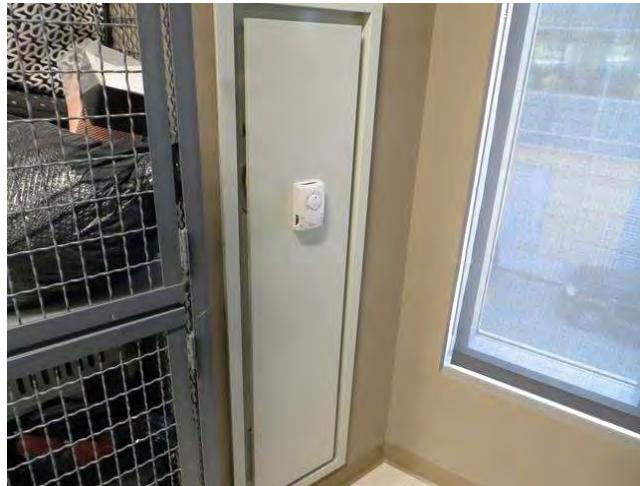
Component covers unit-style water-source heat pumps located in common areas listed.

Tower A:
(2) storage room

Per Kevin Fernandes, cost to replace is \$10,000. Cost just to replace failed compressor is \$3000.

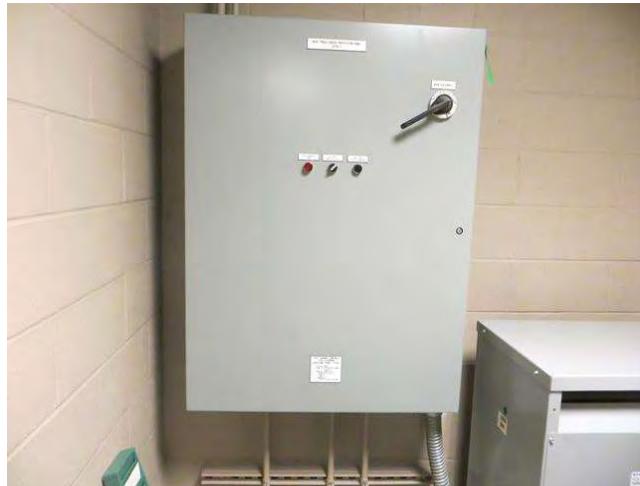
Heat trace system protects elements that contain water from freezing in winter. This includes cooling towers and parking garage piping. There are three control panels in garage and one in Tower A mechanical penthouse. Tyco Thermal Controls is manufacturer.
