RESERVE ANALYSIS REPORT

High Rise Condominium

Sample, New England

November 20, 2017

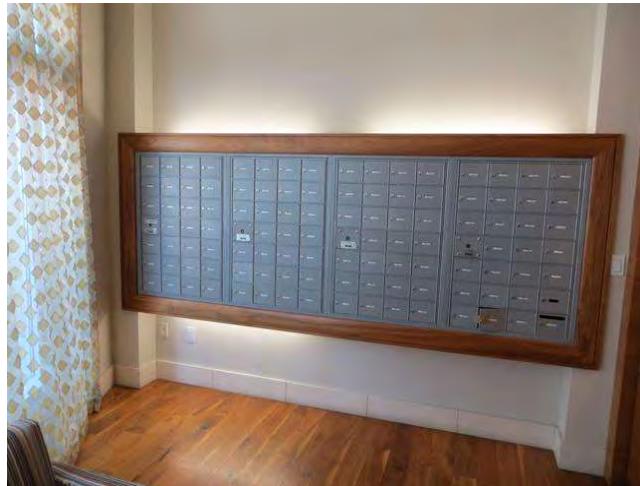
Component covers Salsbury Industries USPS-STD-4B+ mailboxes in tower lobbies.

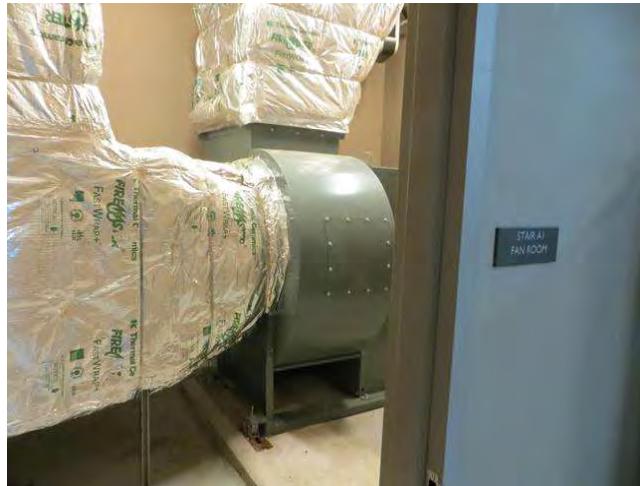
Fire department uses in emergencies to pressurize or depressurize stairwells. Never used operationally.

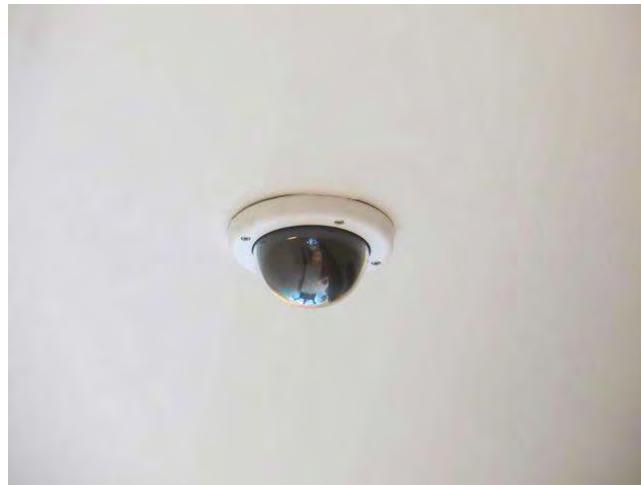
Component covers surveillance system. Original system was analog and lacked detail in camera view. System was upgraded in 2017 with 6 additional cameras and a new DVR/server per client.

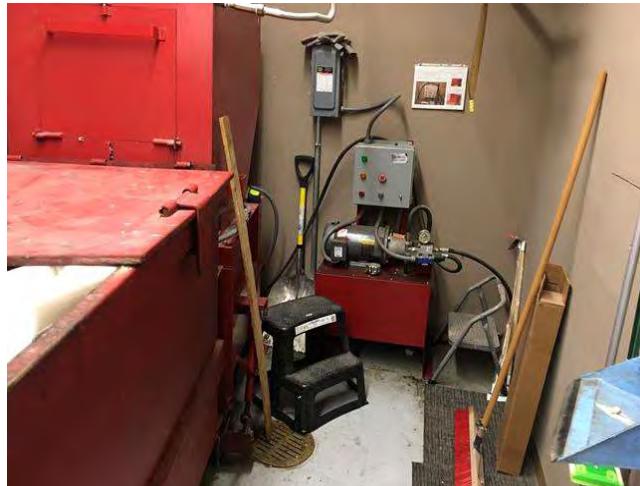
Category	090 Equipment	Quantity	2 compactors
Photo Date	July 2017	Unit Cost	\$29,000.00
		% of Replacement	100.00%
		Current Cost	\$58,000.00
Placed In Service	01/08	Future Cost	\$70,701.68
Useful Life	20	Assigned Reserves at FYB	\$0.00
Remaining Life	10	Monthly Member Contribution	\$591.04
Replacement Year	2028	Monthly Interest Contribution	\$1.31
		Total Monthly Contribution	\$592.36

Manufacturer: U.S. Chutes, Bantam, CT 800-872-4883
 Model 3x3 container/packer, front loading

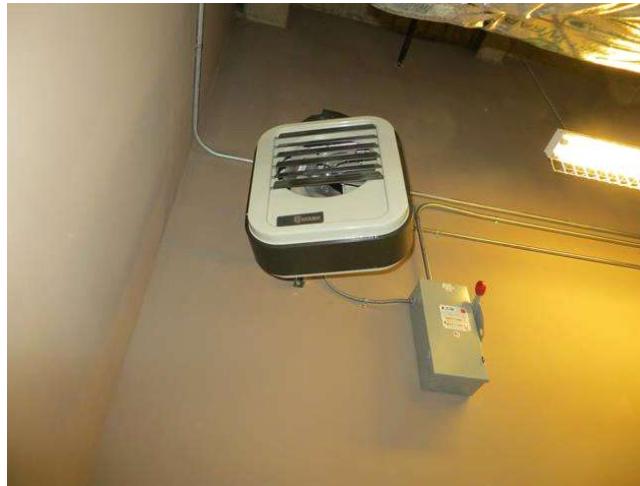
Category	090 Equipment	Quantity	37 unit heaters
Photo Date	July 2017	Unit Cost	\$500.000
		% of Replacement	27.00%
		Current Cost	\$4,995.00
Placed In Service	01/08	Future Cost	\$6,088.88
Useful Life	20	Assigned Reserves at FYB	\$0.00
Remaining Life	10	Monthly Member Contribution	\$50.90
Replacement Year	2028	Monthly Interest Contribution	\$0.11
		Total Monthly Contribution	\$51.01

Electrical unit heaters provide heat to mechanical rooms in garage and stair pressurization fan rooms in mechanical penthouses.

Service contractor: simple units are typically serviced in house. Parts inventory for heaters is available in garage storage room.

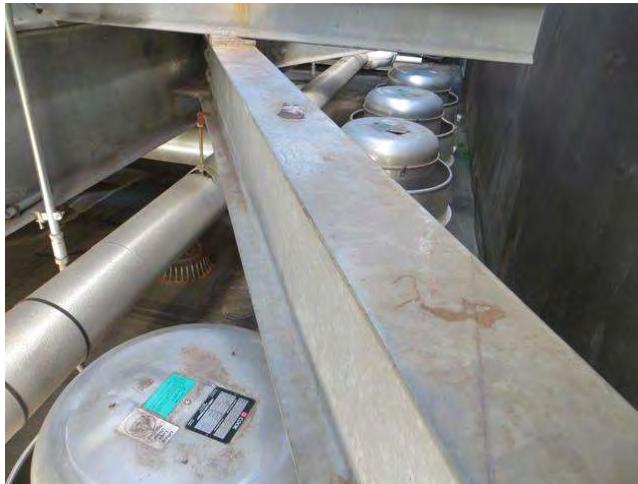
Category	090 Equipment	Quantity	5 fans
Photo Date	July 2017	Unit Cost	\$3,500.000
		% of Replacement	100.00%
		Current Cost	\$17,500.00
Placed In Service	01/08	Future Cost	\$21,332.40
Useful Life	20	Assigned Reserves at FYB	\$0.00
Remaining Life	10	Monthly Member Contribution	\$178.33
Replacement Year	2028	Monthly Interest Contribution	\$0.39
		Total Monthly Contribution	\$178.72

Mushroom fans located under cooling towers are general common area exhaust.
 Loren Cook 120 ACFU 120R3B 50

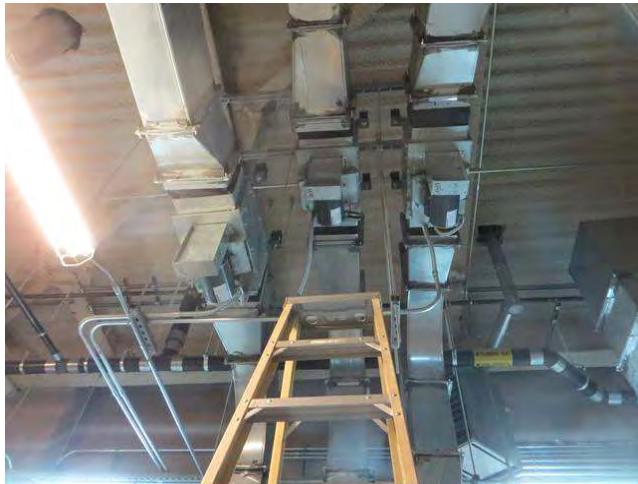
Category	090 Equipment	Quantity	24 fans
Photo Date	July 2017	Unit Cost	\$2,500.000
		% of Replacement	100.00%
		Current Cost	\$60,000.00
Placed In Service	01/08	Future Cost	\$73,139.67
Useful Life	20	Assigned Reserves at FYB	\$0.00
Remaining Life	10	Monthly Member Contribution	\$611.43
Replacement Year	2028	Monthly Interest Contribution	\$1.35
		Total Monthly Contribution	\$612.78

1/2 - 1/6 hp variable speed in line booster fans ventilate unit bathrooms. Quantity from prior reserve study.

Operational experience: Two fan motors recently replaced in house. Motor \$180; (2) hours labor \$200

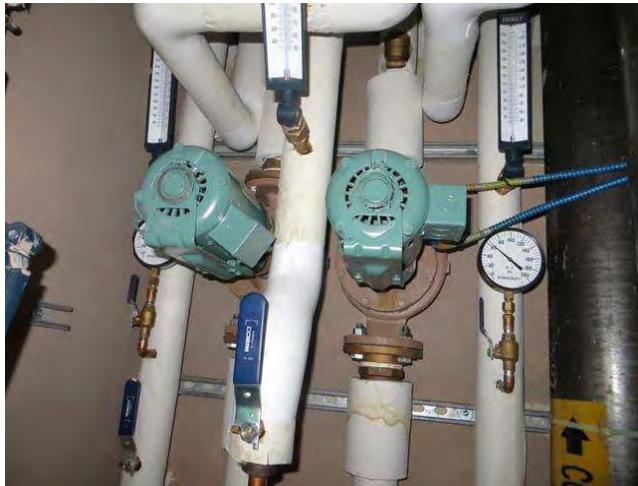
Water is heated to 145 degrees Fahrenheit by PVI main water heaters. Mixing valves in mechanical penthouse temper water to 135 degrees for distribution to building. Hot water is circulated to reduce waiting times. Water for floors 2-10 is pumped both down and up. These pumps send water back up to penthouse. Booster hot water heater on floor 2 is listed as separate component.

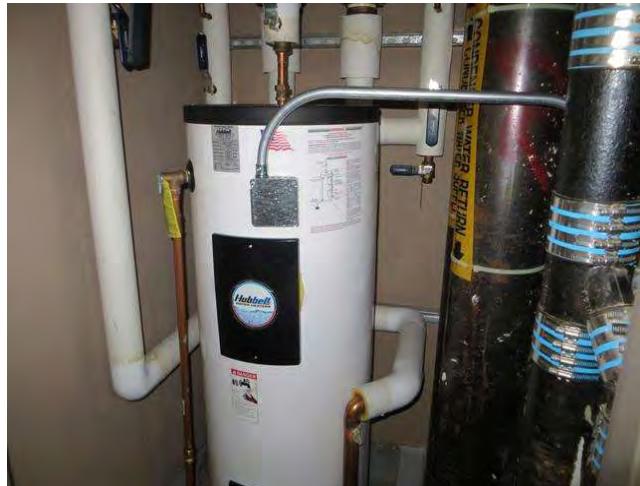
Hubbell 40 gallon electric water heaters have input of 9,000 watts. There is one on second floor of each tower.

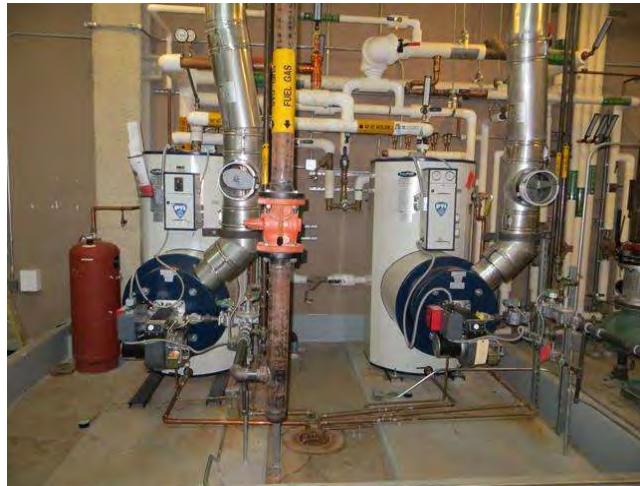
Category	090 Equipment	Quantity	4 water heaters
Photo Date	July 2017	Unit Cost	\$29,500.000
		% of Replacement	100.00%
		Current Cost	\$118,000.00
Placed In Service	01/16	Future Cost	\$132,887.17
Useful Life	8	Assigned Reserves at FYB	\$0.00
Remaining Life	6	Monthly Member Contribution	\$1,946.79
Replacement Year	2024	Monthly Interest Contribution	\$4.30
		Total Monthly Contribution	\$1,951.09

Water is heated to 145 degrees Fahrenheit by PVI main water heaters. Mixing valves in mechanical penthouse temper water to 135 degrees for distribution to building. Hot water is circulated through building to reduce waiting times.

PVI 1000 L 175A-TP gas-fired water heaters have input of 8,000,000 BTU/hr. Tank capacity is 175 gallons. Major parts of water heater: control, burner, tank, mixing valve

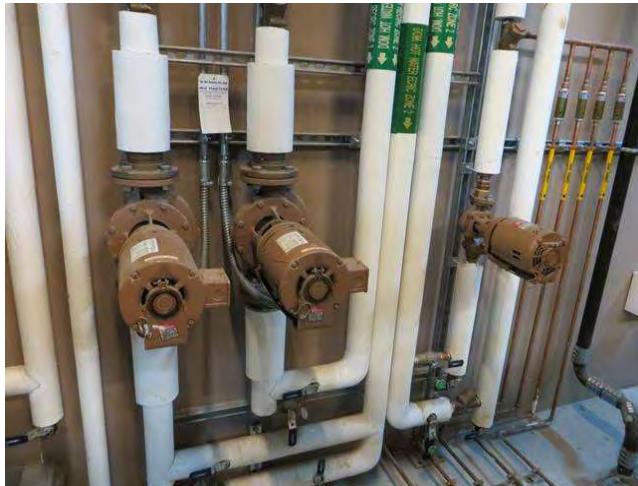
Category	090 Equipment	Quantity	6 pumps
Photo Date	July 2017	Unit Cost	\$1,500.000
		% of Replacement	100.00%
		Current Cost	\$9,000.00
Placed In Service	01/14	Future Cost	\$9,550.87
Useful Life	7	Assigned Reserves at FYB	\$5,142.86
Remaining Life	3	Monthly Member Contribution	\$131.72
Replacement Year	2021	Monthly Interest Contribution	\$2.62
		Total Monthly Contribution	\$134.34

Water is heated to 145 degrees Fahrenheit by PVI main water heaters. Mixing valves in mechanical penthouse temper water to 135 degrees for distribution to building. Hot water is circulated to reduce waiting times. Water for floors 2-10 is pumped both down and up. All of these pumps send water down to building from penthouse.
